SMPE has developed a solution to the common VAG EGR Valve/cooler problem. Blocked or partially blocked DPFs lead to carbon deposit build up, resulting in premature failure of the EGR valve.

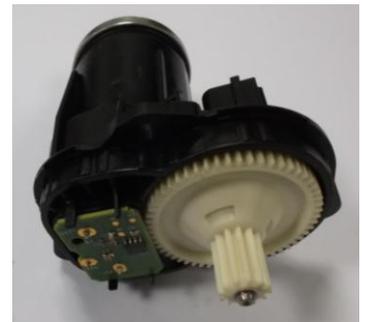
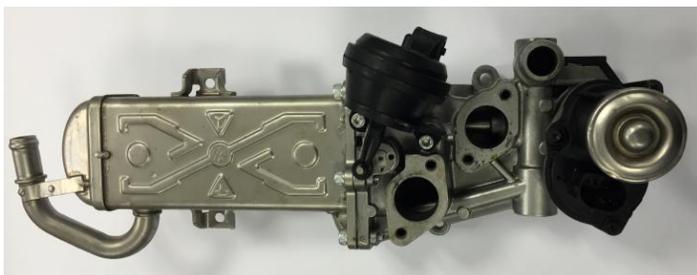
A new SMPE in-house manufactured PCB with custom designed electronics is fitted to the motor assembly

All components are reassembled before the unit is **calibrated** and **tested**. This procedure accurately calibrates the electronic feedback of the valve. The coolant section is then pressure tested to detect any leaks. The final test is to flow gasses through the unit at various pressures and rates to ensure the correct electronic signal is output from the valve
